# BMP Completion Report

Lot 102 South Western Highway, Donnybrook

18 February 2026

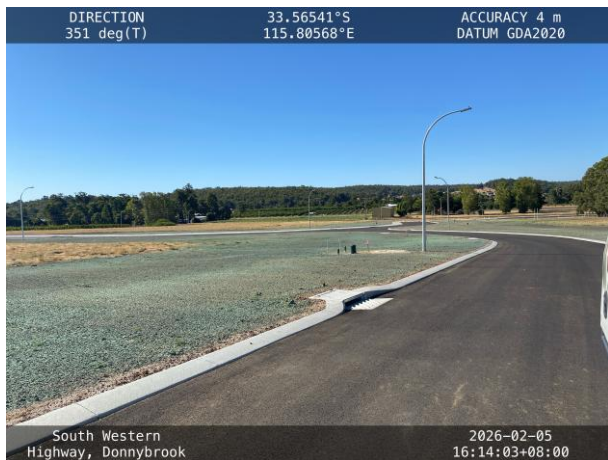
| Landowner | | |
|---|---|---|
| 1 | Establish the access roads to the lot boundaries. | The access roads haven been established to the Lot boundaries, in accordance with the BMP (Photo 1,2 & 3). |

*Photo 1 - Public Road*

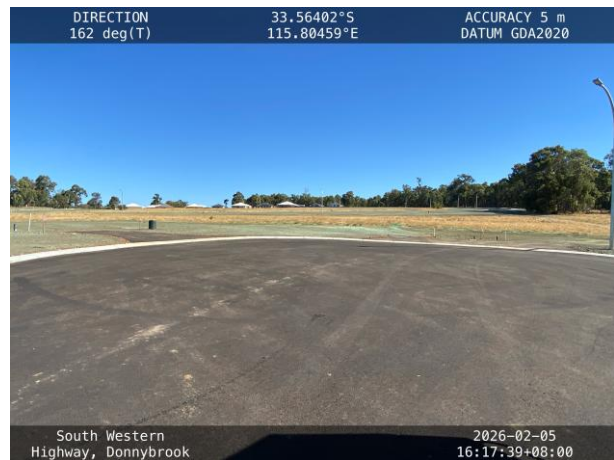
*Photo 2 - Public Road (cul-de-sac head)*

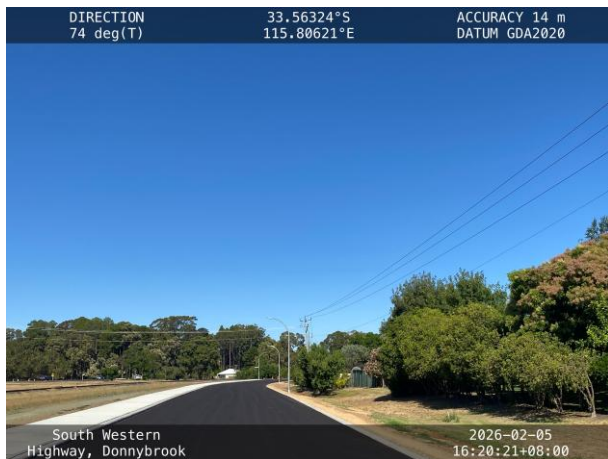
*Photo 3 - Public Road*

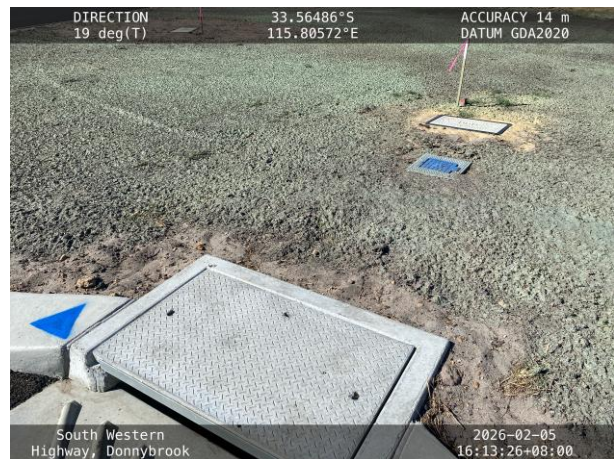
| Landowner | | |
|---|---|---|
| 2 | Establish the water reticulation system and associated infrastructure, including hydrants at the prescribed standard. | Fire hydrants were observed within the Site (Figure 4). The standard of the fire hydrants installed is outside the technical expertise of a Bushfire Consultant. |

*Photo 4 - Fire Hydrant with verge marking*
