# BMP Completion Report

Lot 102 South Western Highway, Donnybrook

18 February 2026

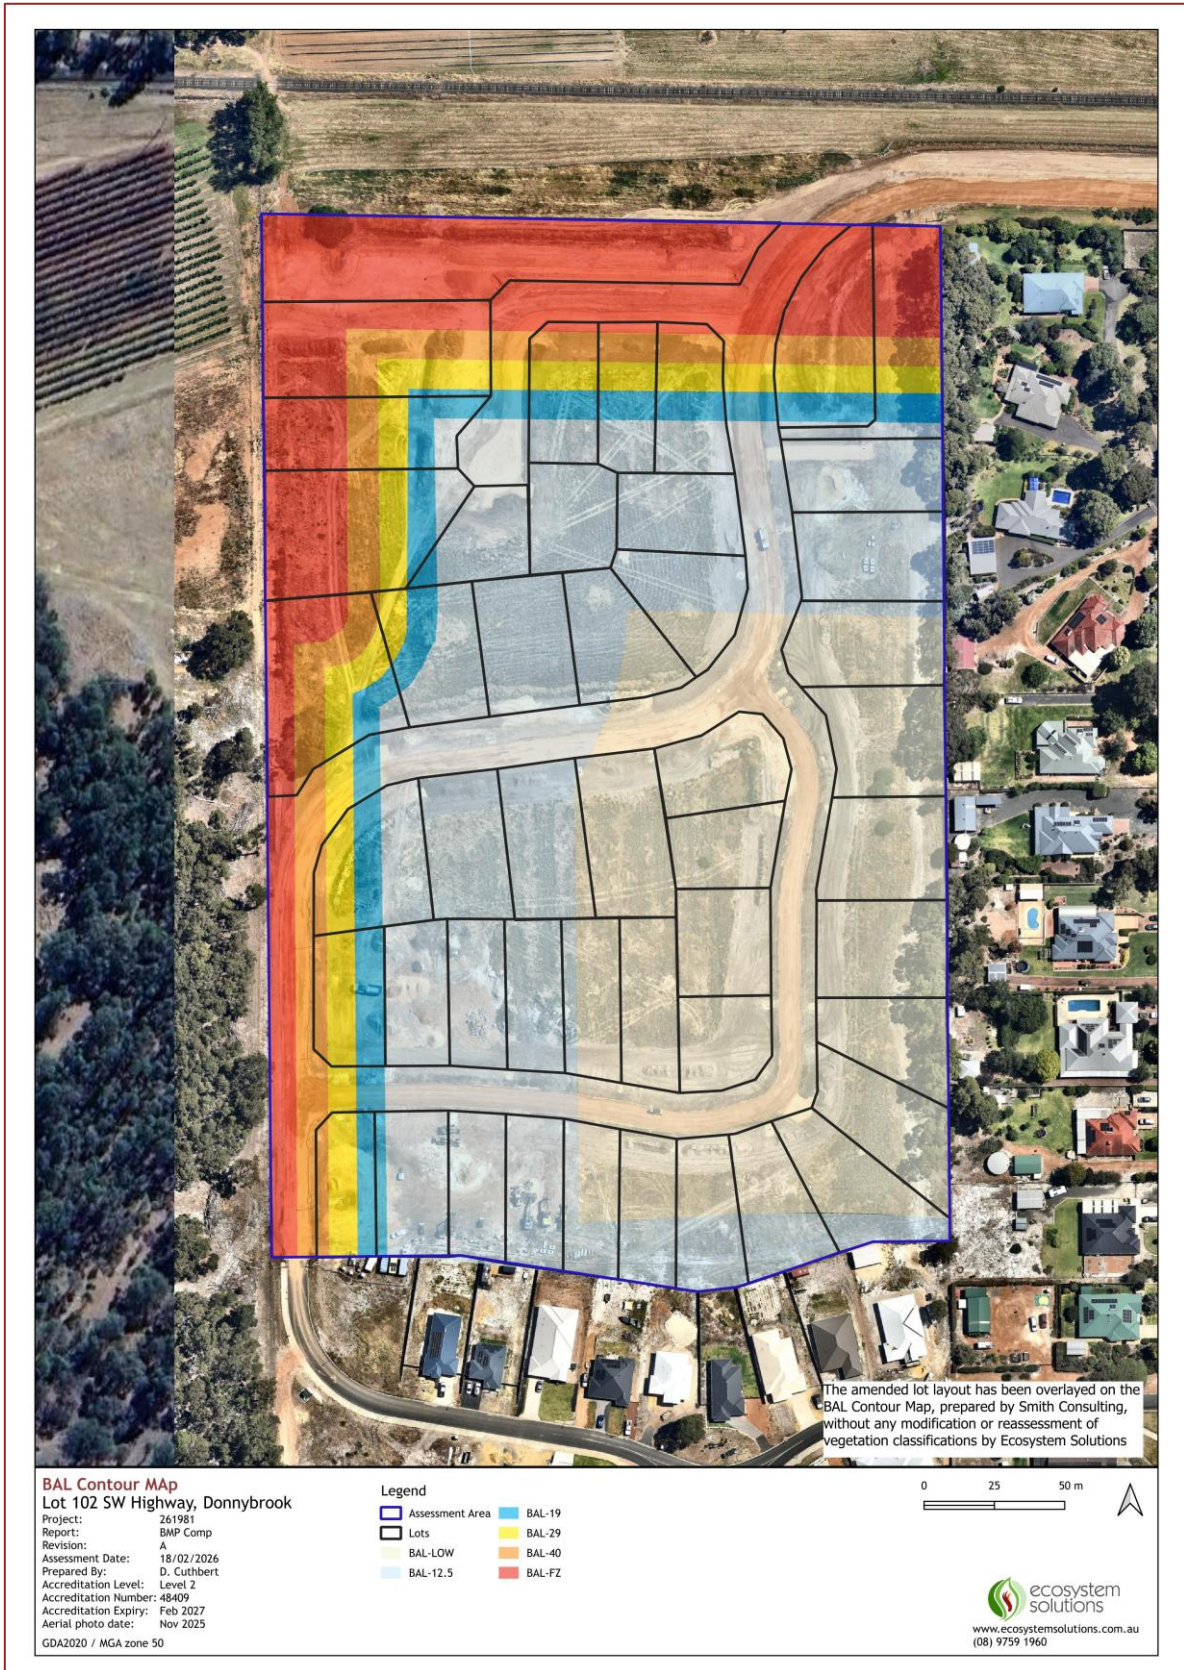
**Figure 2** BAL Contour Map (Smith Consulting), showing updated lot layout

The lot layout has changed since the BMP has been approved; therefore, a BAL Contour Map has been requested showing the amended lot layout. The amended lot layout has been overlayed on the BAL Contour Map, prepared by Smith Consulting, without any modification or reassessment of vegetation classifications by Ecosystem Solutions<sup>1</sup>, this map is provided in Figure 2.
